Manhole Inspection Summary

Manhole # S21II_022MH

Insp Date: **6/21/07 2:20 PM**

Location Address: **1701 MONROE-APPLETON**

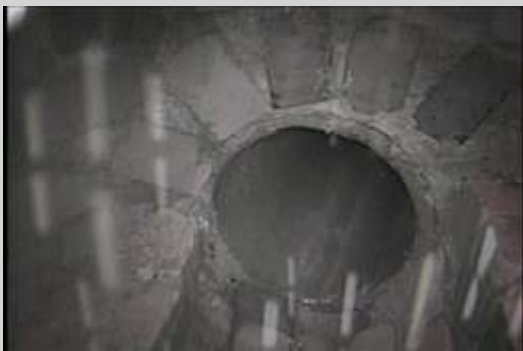
3 O'Clock Inflow

8 in. Circular Gravity Sewer
Pipe In @ 3 O'Clock

Pipe Height: **8.4** (in.) Rod and Bar (Angled)
Pipe Material: **Clay** ☐ Pipe Lined
Invert Depth: **7.40** (ft.) Flow Characteristics: **Slow**
Deposits: ☒ **None** ☐ Mud ☐ Sludge ☐ Debris ☐ Grease
Silt Depth: (in.) Deposits Extent:
Infiltration: **None** Pipe Seal Cond: **Sound**

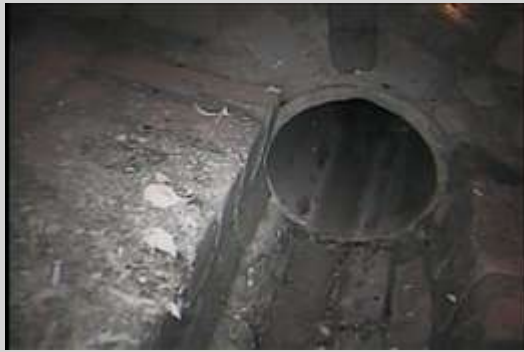
7 O'Clock Inflow

Pipe In @ 7 O'Clock

Pipe Height: **8.4** (in.) Rod and Bar (Angled)

Invert Depth: **7.66** (ft.) Flow Characteristics: **Slow**

Deposits: ☒ None ☐ Mud ☐ Sludge ☐ Debris ☐ Grease

Infiltration: **None** Pipe Seal Cond: **Sound**

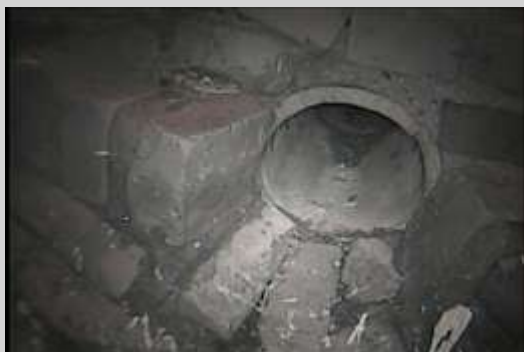
9 O'Clock Inflow

Pipe In @ 9 O'Clock

Pipe Height: **8.4** (in.) Rod and Bar (Angled)

Infiltration: **None** Pipe Seal Cond: **Sound**
